STRUCTURAL HEALTH MONITORING OF BRIDGES IN SWEDEN

M. Enckell
Royal Institute of Technology (KTH), Sweden

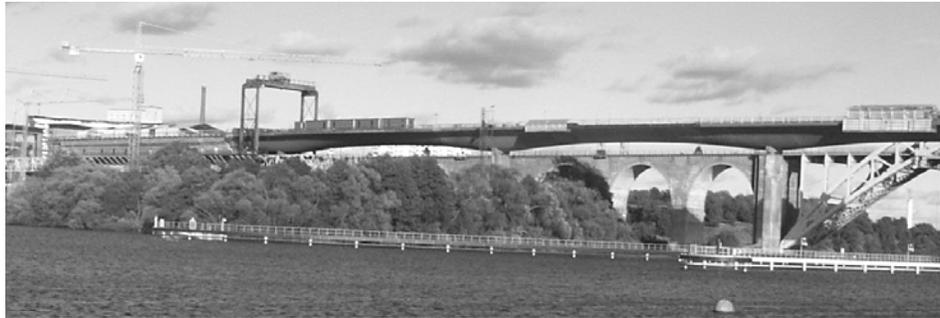
Figure 1. Longitudinal view of the New Årsta Railway Bridge during construction

The New Årsta Railway Bridge is 833 m long, 19.5 m wide and has a vertical clearance of 26 meters. The piers have an elliptical cross-section. The bridge accommodates 2 railway tracks, pedestrian and cycle road as well as the service road. The length of the main nine spans is 78 m. Figure 1 illustrates the bridge during its construction period. The Old Årsta Bridge can be seen in background.

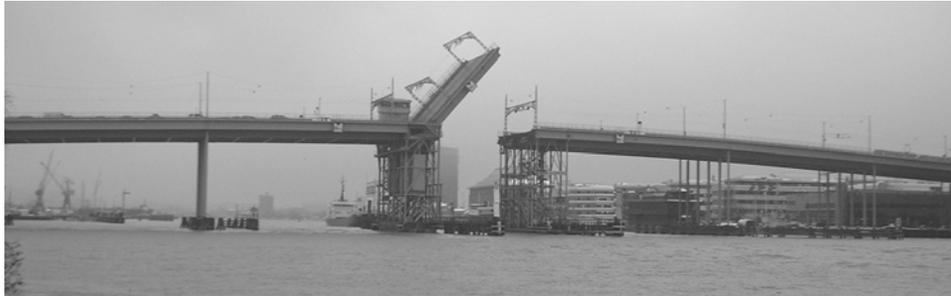
Figure 5. Side view of the Götaälvbridge during bridge opening
